National Register of Historic Places Multiple Property Documentation Form

L-4 Fire Lookouts in the USFS Northern Region (Region 1), 1932-1967

The Role of the L-4 Lookout House in the Development of the US Forest Service Region 1's Fire Detection System

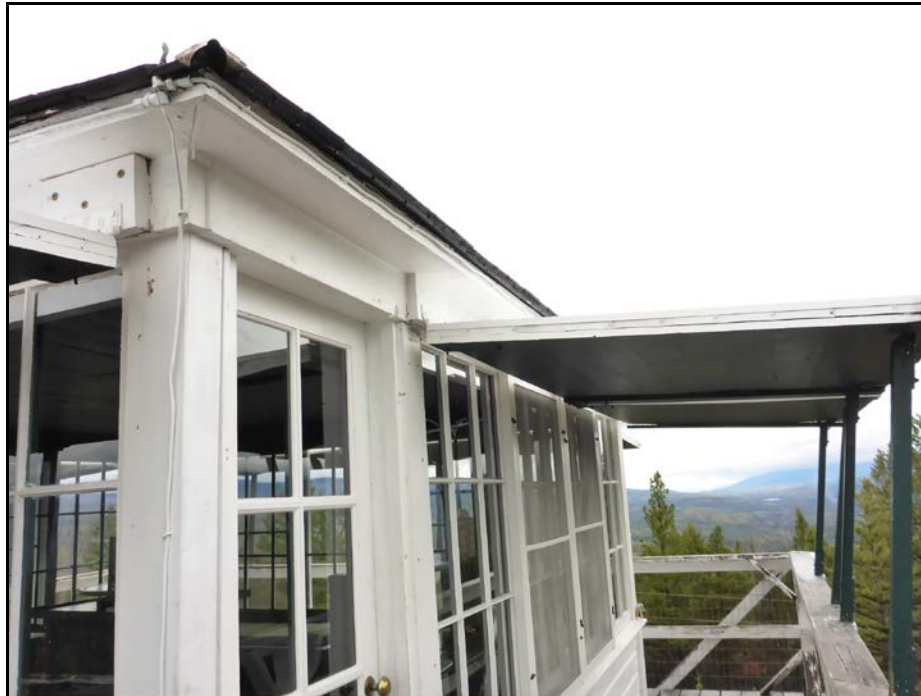
Figure 6. Double Arrow Lookout on the Lolo National Forest, an original 1931-plan with struts holding the shutters open (Sydney Bacon, 2016).

The majority of the replacement units provided by the regional office appear to have been modified versions of the 1931 pyramidal roof L-4. In general dimensions, this later version was similar to the 1931 plan, with a 14' by 14' footprint and a pyramidal hip roof. A major change was an "improved" system of fixing the shutters in the open position. In Fickes' original design the top-hinged shutters were simply propped open with 2" x 2" struts secured to the catwalk railing or the base of the lookout house if the house was built on the ground (Figure 6).

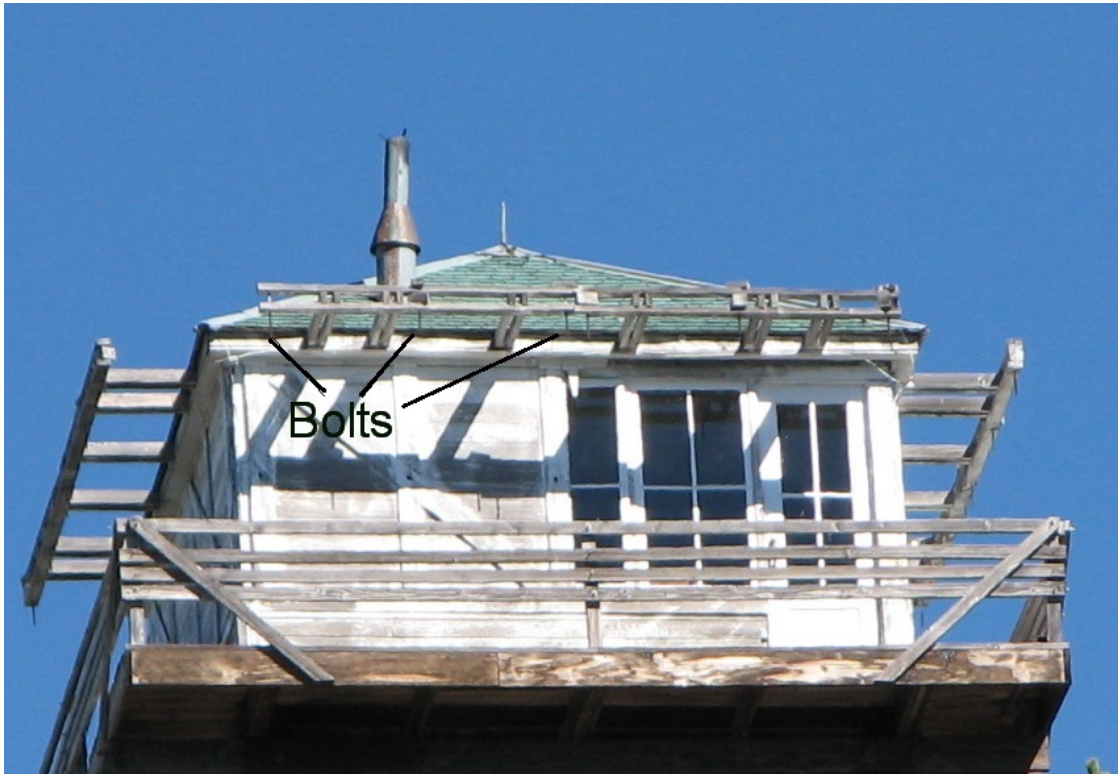
Figure 7. Mineral Peak Lookout on the Lolo National Forest: a modified L-4 plan with outriggers to hold shutters open (CRCS 2016).

In the modified plan, raised shutters were bolted to an “outrigger.” The outrigger was formed by extending the interior ceiling rafters beyond the four exterior walls of the building. Two 2” x 4” plates were attached perpendicularly to the extended rafters. Threaded bolts evenly spaced along each plate extended down from the plates (Figure 7). When the shutters were raised, the bolts fit through holes in the shutter and were held in place with wing nuts. The revised plan also included four-light window sash, with one in the center of each wall opening casement fashion, and fir floors rather than maple floors specified in the 1931 version. The plans for this revised version of the L-4 originated from Region 6 (Washington and Oregon), and approved by the regional forester in 1936 and amended in 1944 and 1948.<sup>43</sup> By the early 1950s, changes had also been made to tower design. New specifications called for straight tower legs and the use of treated timber.
